LECTURE 14: MRI/FMRI SAFETY

MR SAFETY

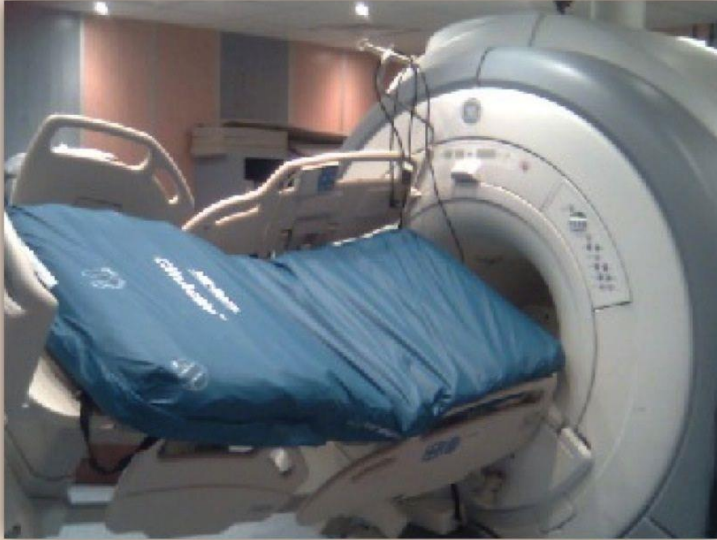
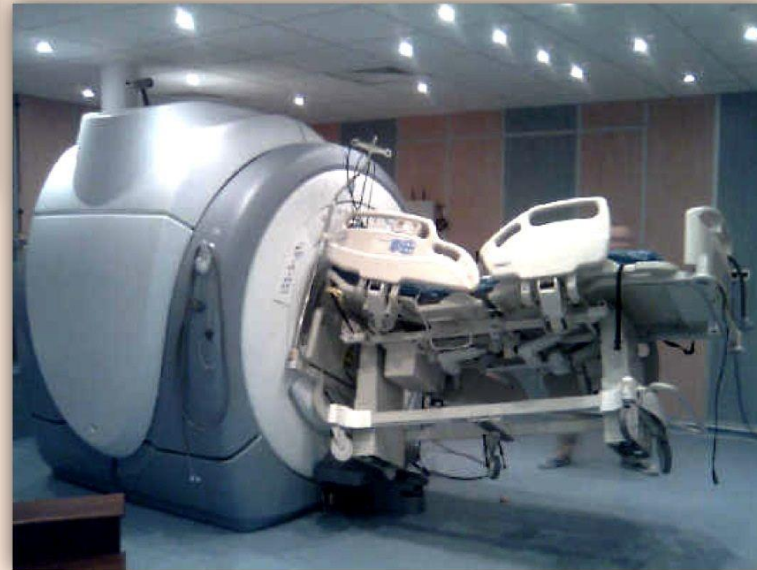
Missile Effect

MISSILE EFFECT

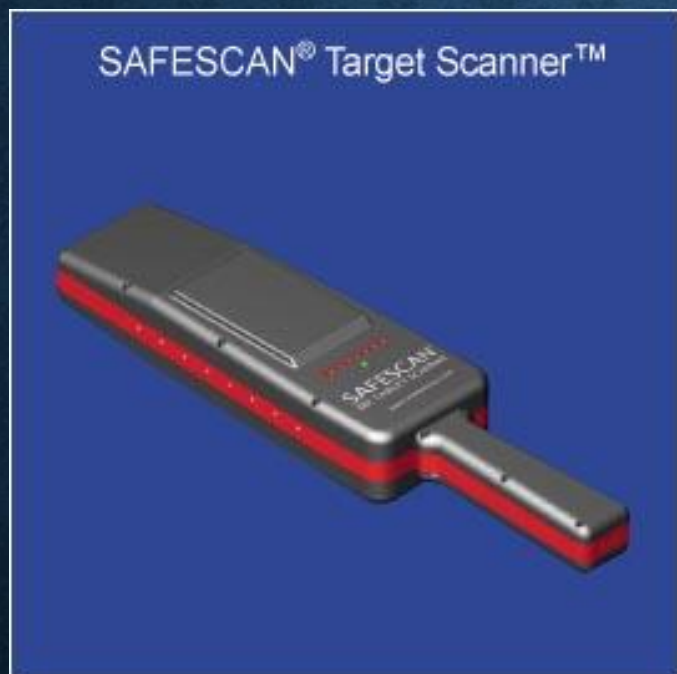
FERROUS DETECTION

- ❖ Alarms **ONLY** for ferromagnetic objects
- ❖ Can be used for superficial detection

Ferromagnetic detection is intended to supplement - but NOT replace screening procedures.

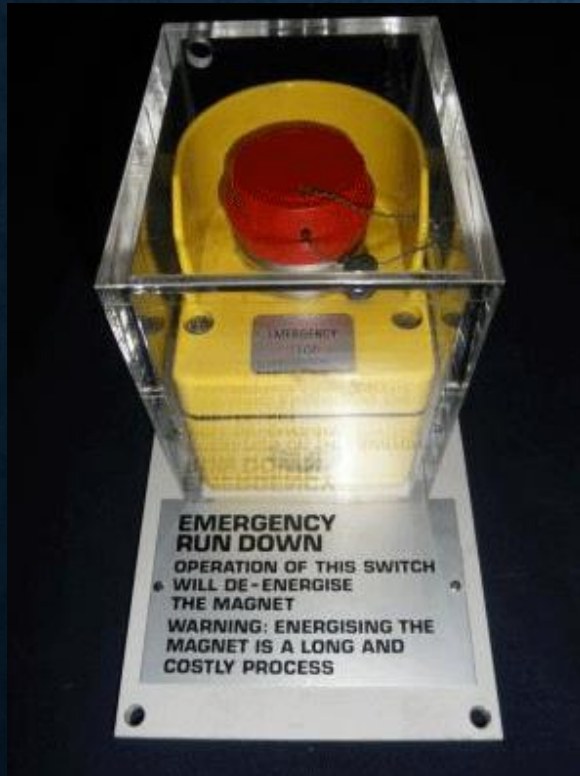
ALL MRI SCANNERS HAVE A QUENCH BUTTON

- What -
 - A quench is the sudden loss of superconductivity when the temperature is raised
 - Coil temperature rises above the superconductivity threshold, the windings suddenly develop a finite resistance
 - This creates heat causing a sudden, explosive boil-off of liquid helium
 - Creates a loss of the static magnetic field of the scanner
- Why -
 - Quenching can be done in emergency situations
 - Magnets can spontaneously quench

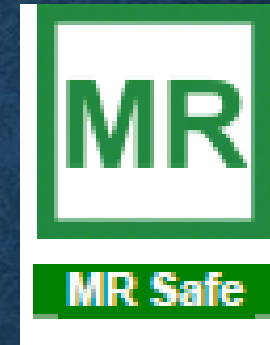
MR SAFE

an item which poses no known hazards in all MR environments

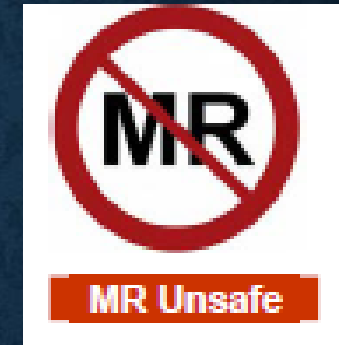
MR UNSAFE

an item which is known to pose hazards in all MR environments.

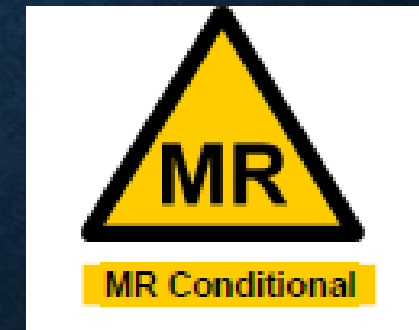
MR CONDITIONAL

An item which has been demonstrated to pose no known hazards in a specified MR environment with specified conditions of use. Field conditions that define the specified MR environment include field strength, spatial gradient, dB/dt (time rate of change of the magnetic field), radio frequency (RF) fields, and specific absorption rate (SAR). Additional conditions, including specific configurations of the item, may be required.

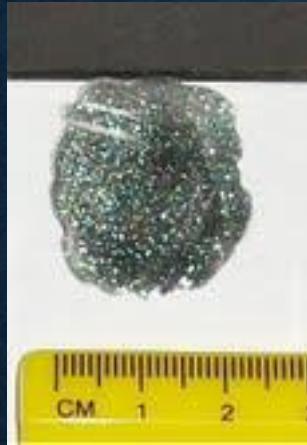
ARTIFACTS FROM METAL

- Non-ferrous metal can be brought into the MRI environment
- These are not attracted to the magnet but still interact with the magnetic field
- Interactions can lead to local distortions that cause artifacts in the MRI scan

Dental Work

Braces
